97-17, *Publication Date: AUGUST 18, 1997*

<ul style="list-style-type: none">• Fluid - AODE/4R70W - Fluid Leak At Transmission Oil Cooler At Radiator - Service Tip• Transmission - AODE/4R70W - Fluid Leak At Transmission Oil Cooler At Radiator - Service Tip	Article No. 97-17-16
--	---------------------------------

1994-97 THUNDERBIRD

1994-97 COUGAR

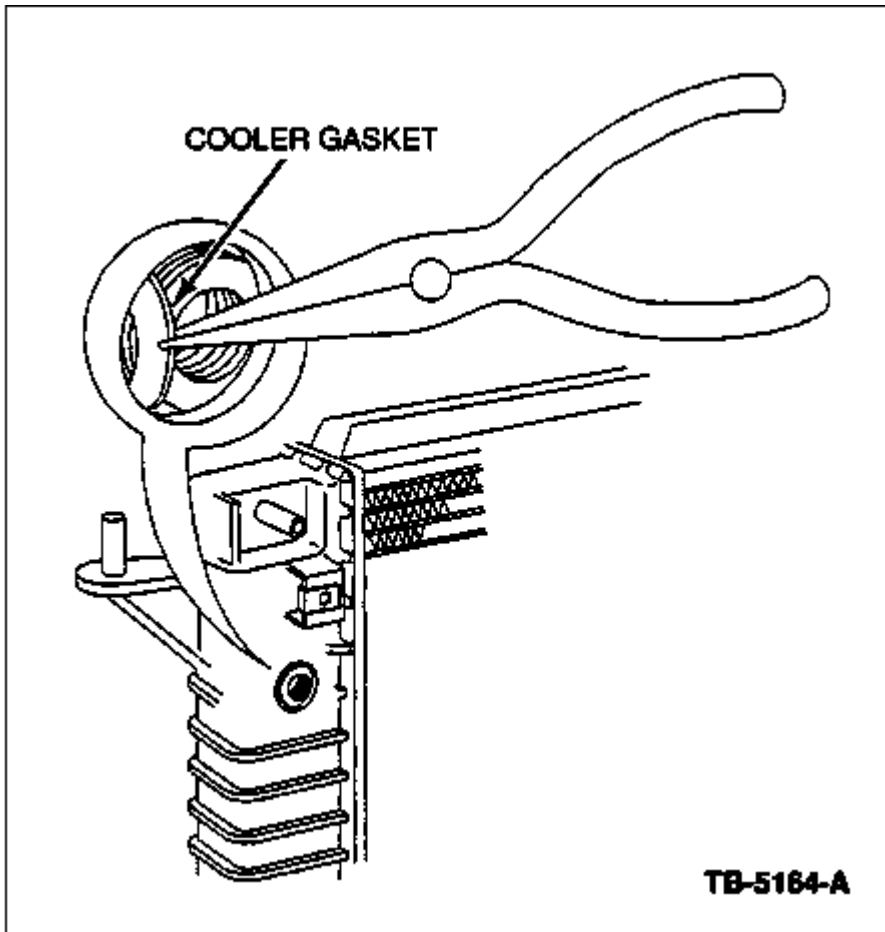
Figure 4 - Article 97-17-16

A transmission fluid leak may be present at the transmission oil cooler at the radiator. This may be caused by a leaking transmission oil cooler gasket.

8. Remove the gasket (Figure 4).

9. Install a new Transmission Oil Cooler Gasket (E77Z-8C242-AA) by placing the gasket over the cooler fitting, pushing down on the oil cooler and carefully working the gasket around the fitting into position.
10. Reinstall jam nut and washer, and torque to 15-19 N-m (11-14 lb-ft).
11. Install the oil cooler line fitting and torque to 23-33 N-m (17-24 lb-ft).
12. Repeat Steps 5-11 for the other cooler fitting if necessary.
13. Reinstall the radiator. Refer to the appropriate Thunderbird/Cougar Service Manual.
14. Refill the transmission and cooling system.
