## TSB-89-6-6

1989 THUNDERBIRD

1989 COUGAR

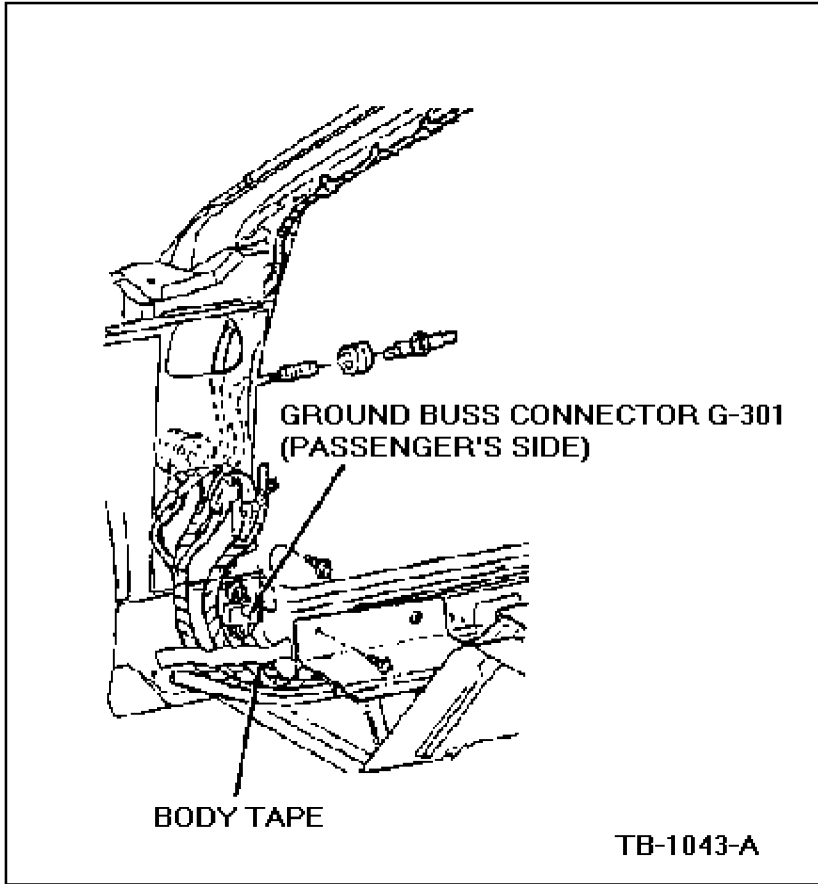
Figure 1 - Article 89-6-6

A no start condition or power accessories that do not work may be caused by a loose or disconnected wire at the ground buss connector. The wire leads from the ground buss connectors may be looped under the carpet at the lower edge of the cowl trim panel. This type of routing allows the occupants feet to apply enough downward pressure on the carpet to pull one or more ground terminals from the ground buss connector. Accessories and systems that could be affected are in the 1989 Electrical Vacuum Troubleshooting Manual (EVTM), pages 16 through 19. A partial list of these accessories and systems are:

1. Using the 1989 Thunderbird/Cougar EVTm, pages 16 through 19, determine which ground buss connector (G-300 or G-301) requires service, Figures 1 and 2.

5. If a wire(s) is loose or pulled out of a terminal(s), remove the terminal(s) from the ground buss connector and solder the wire(s) to the terminal(s).
6. Re-install the repaired terminal(s) in the ground buss connector.
7. Reposition the ground buss connector. Rotate the ground buss connector either forward or rearward to allow the ground wire leads to be as close to the cowl as possible.
8. Install a 4-6 inch piece of body tape on the wire harness to hold it to the cowl panel, Figures 1 and 2.
9. Re-install the cowl trim panel.
