## TSB 97-17-16

1994-97 THUNDERBIRD

1994-97 COUGAR

A transmission fluid leak may be present at the transmission oil cooler at the radiator. This may be caused by a leaking transmission oil cooler gasket.

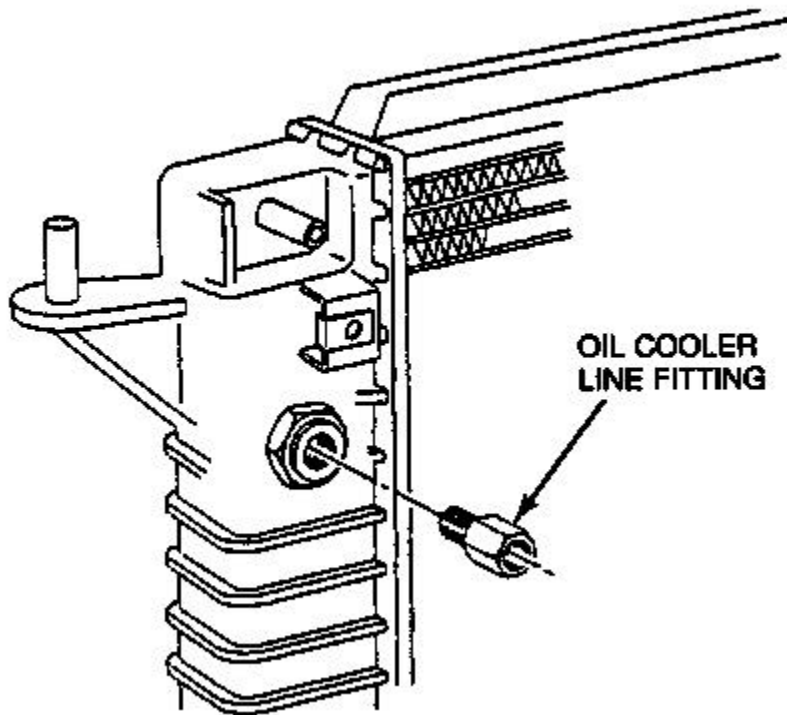
Figure 1 - Article 97-17-16

1. Verify the fluid leak is coming from the connection at the radiator end tank fitting.
2. Drain the cooling system.
3. Remove the radiator as outlined in the appropriate Thunderbird/Cougar Service Manual.
4. Lay the radiator flat on a bench. Be careful not to damage the cooling fins and/or tubes.
5. Remove the oil cooler line fitting (Figure 1).

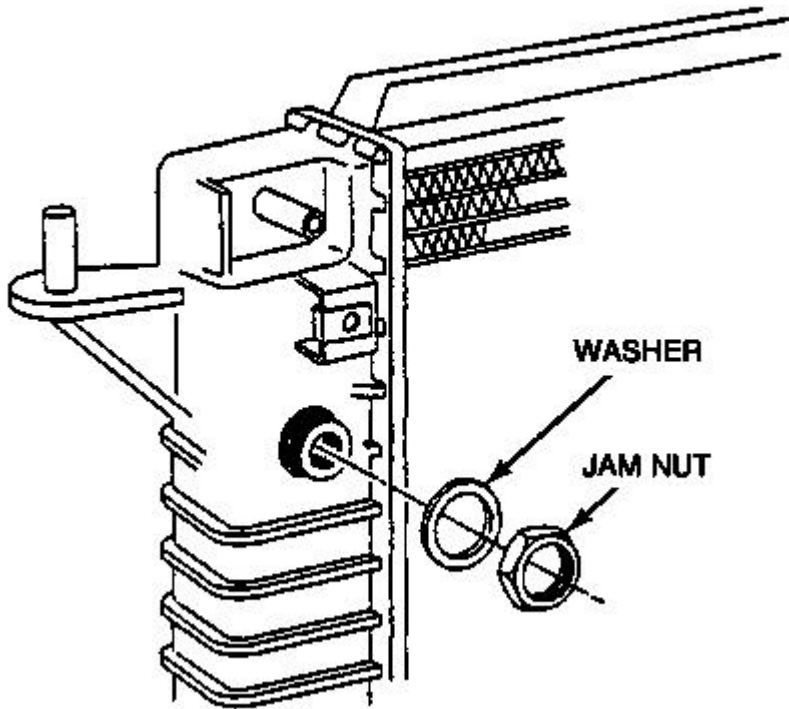
Figure 2 - Article 97-17-16

6. Remove the jam nut and washer (Figure 2).

- 9. Install a new Transmission Oil Cooler Gasket (E77Z-8C242-AA) by placing the gasket over the cooler fitting, pushing down on the oil cooler and carefully working the gasket around the fitting into position.
- 10. Reinstall jam nut and washer, and torque to 15-19 N-m (11-14 lb-ft).
- 11. Install the oil cooler line fitting and torque to 23-33 N-m (17-24 lb-ft).
- 12. Repeat Steps 5-11 for the other cooler fitting if necessary.
- 13. Reinstall the radiator. Refer to the appropriate Thunderbird/Cougar Service Manual.
- 14. Refill the transmission and cooling system.

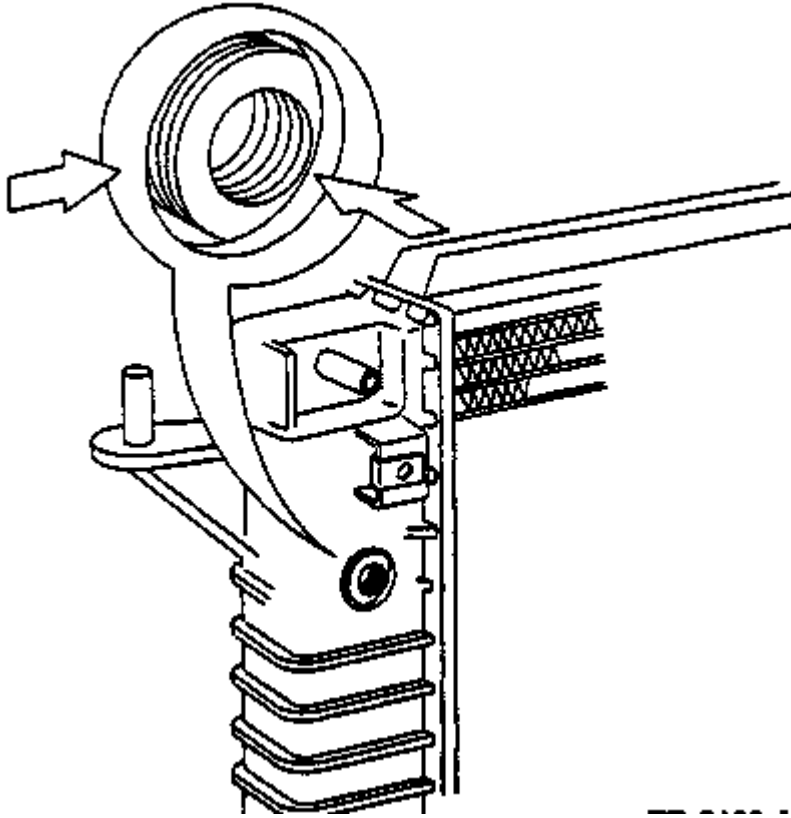
Figure 3 - Article 97-17-16

7. Push down on the transmission oil cooler and slide to the side under the lip of the end tank (Figure 3).

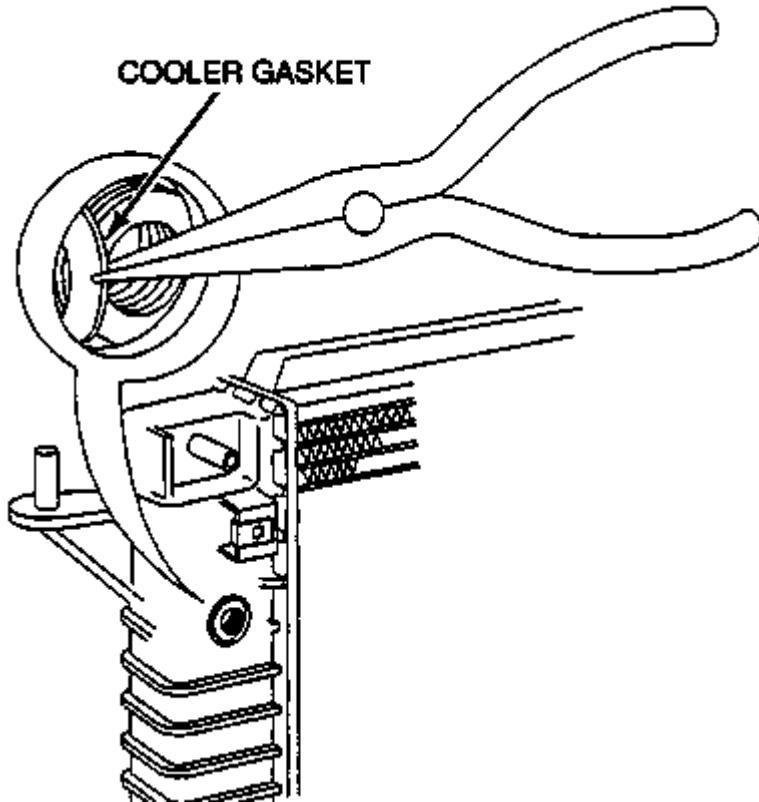
Figure 4 - Article 97-17-16

- 8. Remove the gasket (Figure 4).
